Clavicle Fracture Solutions - Case Series

Locking Clavicle Plating System

Dual-Trak Clavicle Screw System

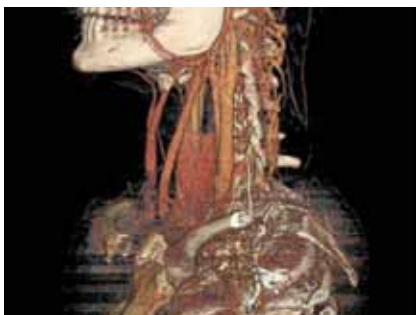
Figure 1: Preoperative CT Scan

The patient is a 15-year-old male, who presented with severe pain to the medial portion of the clavicle following a motor vehicle accident. He sustained a direct blow to his chest when it hit the steering wheel. Physical examination found severe tenting of the skin anteriorly near the insertion of the clavicle to the sternum. A 3D CT scan demonstrated a rare medial clavicle fracture (Figure 1). This only occurs with approximately five percent of all clavicle fractures. 3D CT scans are recommended with medial fractures as anatomic structures may obscure the view of the fracture as seen with regular X-rays.

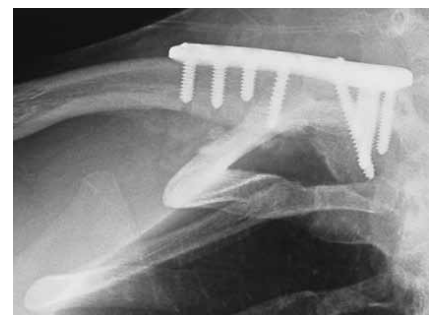
Figure 3: Postoperative Radiograph

The A/P radiograph shows anatomic restoration of the clavicle (Figure 3). Multiple screws were able to be placed medially into the medial head fragment and the locking/nonlocking screws were placed laterally into the shaft. This restored the anatomy and took away the prominence that the patient had preoperatively due to the amount of separation.

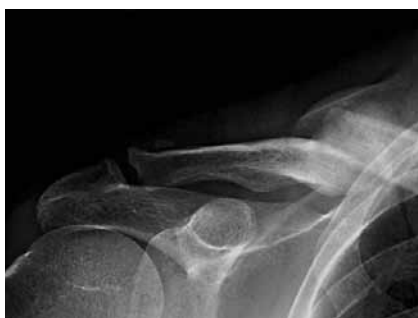
Figure 1: Preoperative Radiograph

A preoperative radiograph displayed that the previous clavicle injury had healed in a malunion. The subsequent overlap and the sharp bony prominence superiorly were the sources of the soft-tissue irritation (Figure 1).

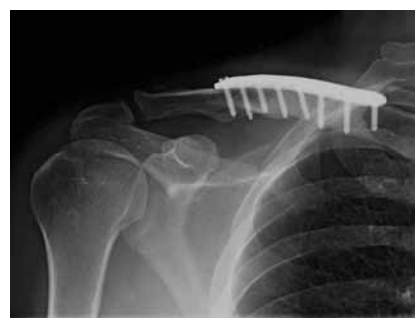
Figure 3: Postoperative Radiograph

The A/P radiograph shows healing of the clavicle malunion after it was stabilized with the Acumed® Locking Superior Clavicle Plate (Figure 3).

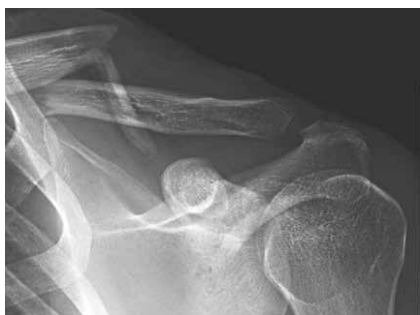
Figure 1: Preoperative Radiograph

An A/P radiograph shows a fracture of the middle third of the clavicle, overlapped approximately 2 cm with a butterfly fragment flipped 90° vertically (Figure 1). It has been shown in several series that fractures displaced 15 to 20 mm or more, have a poor prognosis with lower rates of both healing and patient satisfaction. This is particularly the case with an associated vertical butterfly fragment.

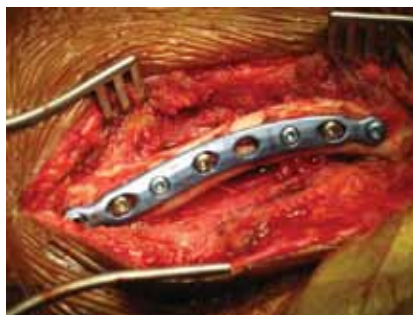
Figure 2: Intraoperative photograph

Because of the amount of displacement of the fracture, the clavicle is stabilized with an Acumed® precontoured 8-Hole Locking Superior Clavicle Plate and 3.5 mm locking and nonlocking screws. In this instance, one of the oblong compression slots in the center part of the plate was left devoid of a screw and used to help lag the fracture

fragments. In particular, the lag screw captured and stabilized the butterfly fragment. It is important to note the utility of the precontoured plate as a template to help facilitate reduction of the complex S-shaped curve of the clavicle (Figure 2).

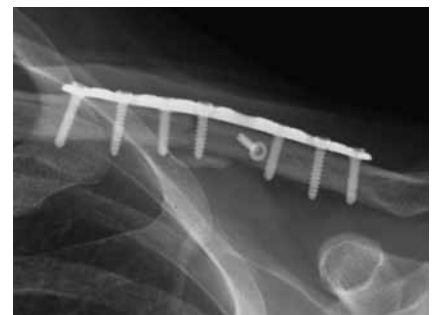
Figure 3: Postoperative Radiograph

The final post-op A/P radiograph shows anatomic restoration of the clavicle (Figure 3). Note how the low-profile plate design is thick in the middle and thin in the periphery to decrease soft-tissue irritation. In fractures of the middle medial third, the plate is utilized as marked. In fractures of the middle lateral third, the plate is frequently rotated 180° to fit the complex curves of the clavicle.

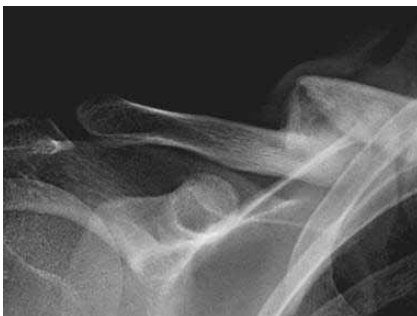
Figure 1: Preoperative Radiograph

Visual observation showed the medial fragment was tenting the skin causing severe pain and soft-tissue irritation. Physical examination confirmed inferior and medial displacement of her right shoulder girdle compared to her left. The medial and lateral fragments overlapped approximately 20 mm, causing marked clinical deformity. Additionally, the patient was experiencing crepitus and a limited range of motion. Subsequent radiographs showed the severe superior displacement of the medial fragment in relation to the lateral fragment (Figure 1).

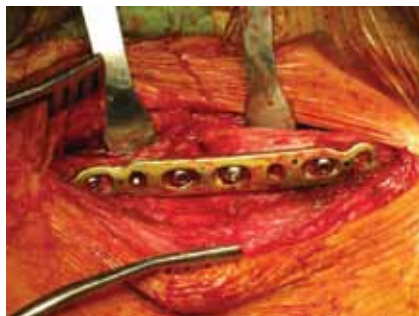
Figure 2: Intraoperative photograph

In this instance, an Acumed® 8-Hole Locking Anterior Clavicle Plate was utilized for several reasons (Figure 2). First, the oblique fracture pattern facilitated the use of an anterior plate for lack of fixation superiorly. Second, given the shape of the patient's clavicle, an anterior approach allowed for greater screw purchase. Third, the anterior-posterior plane is ideal for lag screw fixation through the anterior placed clavicle plate. Finally, as the patient was very thin, anterior placement of the plate decreased the potential for soft-tissue irritation from a book bag or purse over the top of her shoulder.

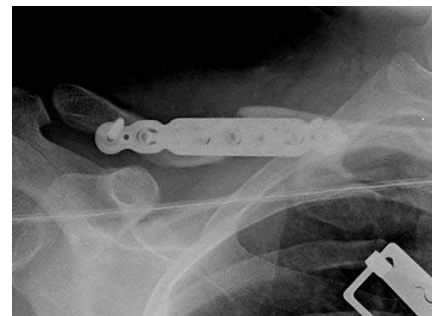
Figure 3: Postoperative Radiograph

The A/P Radiograph confirms reduction of the clavicle fracture with the Acumed® Locking Anterior Clavicle Plate (Figure 3). The medial fragment is now aligned with the lateral fragment, as opposed to the severe step-off that the patient had preoperatively.

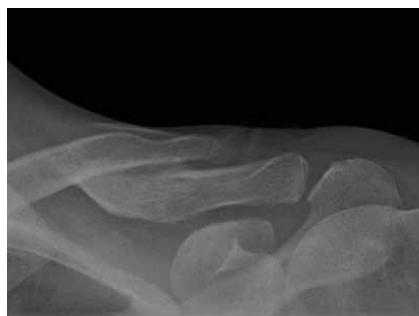
Figure 1: Preoperative Radiograph

An A/P radiograph demonstrated the severe overlap of the medial fragment as compared to the lateral fragment (Figure 1). The fracture was located at the junction of the lateral middle third of the clavicle.

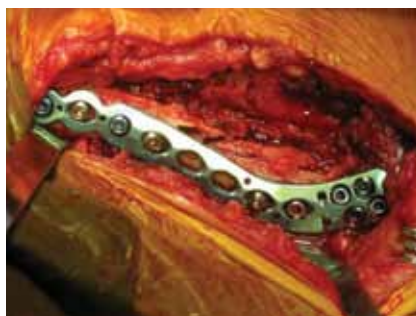
Figure 2: Intraoperative Photograph

Surgeons have the option of selecting distal plates with either 3, 4 or 8-Hole options in the lateral flare depending on the amount of comminution of the lateral fragment. In this instance, the lateral fragment was fairly large and the Acumed® 3.5 mm Locking Distal Clavicle Plate offering four lateral locking holes was selected. An intraoperative photograph shows using the plate as a template to facilitate reduction of the comminuted fracture (Figure 2). The plate was used to help bring the fracture out to length for an anatomic

reduction. After utilizing the plate as a template to help secure the reduction, the plate was filled with 3.5 mm locking and nonlocking screws. Sutures were then passed from medial to lateral around the coracoid and the plate to take stress off of the lateral fixation.

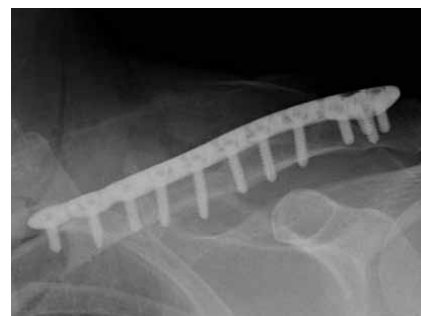
Figure 3: Postoperative Radiograph

The A/P radiograph shows the clavicle restored to its original length and anatomic restoration of the curvature (Figure 3).
