Acu-Loc[®] 2 Wrist Plating System

Complex Distal Radius Fracture Treatment Using Plate Fixation

Case Study

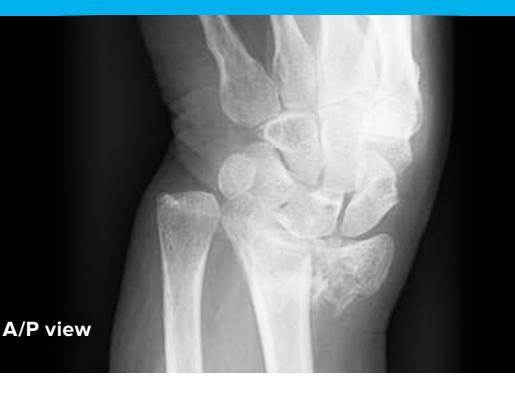
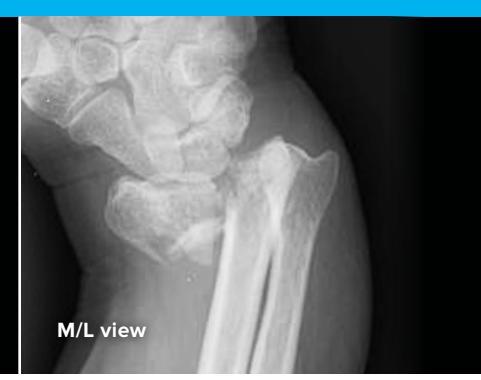
The patient is a 61-year-old female who sustained a complex distal radius fracture after falling from a step. She was initially seen in an emergency department, where a reduction was attempted. The patient was referred for definitive treatment. Given the complex, intraarticular nature of the fracture, operative intervention was recommended. Surgical options included external fixation, spanning wrist plate, or volar distal radius plate fixation.
