Case Series: Fixation of Diaphyseal Forearm Fractures

Treated with the Anatomic Midshaft Forearm Plate System

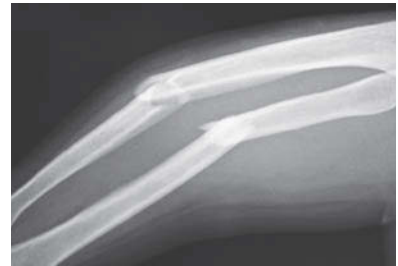
X-Rays

Indication: Acute Left Radius and Ulna Fracture

Product: Acumed® 6-hole Locking Midshaft Ulna Plate and 6-hole Locking Midshaft Volar Radius Plate

The precontoured Acumed® Midshaft Radius and Ulna Plates are extremely utilitarian for these fractures. Also, the presence of both locking and nonlocking holes lends the ability to either compress or lock different parts of the fracture, as the fracture pattern dictates. Consequently, fixation and stability improves, while operative time decreases.

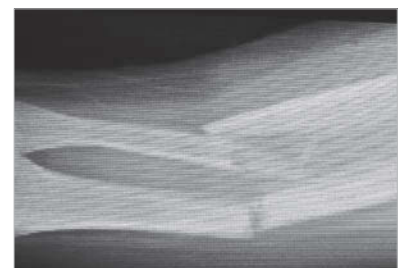
X-Rays

Indication: Left Radius and Ulna Fracture

Product: Acumed® 8-hole Locking Midshaft Volar Radius Plate and 8-hole Locking Ulna Plate

On hospital day number two, the patient underwent an open reduction internal fixation of both her radius and ulna through two separate incisions. We noted the precontoured nature of the plate matched the curvature of the native radius, making the fixation more anatomic. Similarly, the varying locking and nonlocking holes made fixation easier and more rigid. The patient healed uneventfully and by six weeks had resumed almost normal activity.

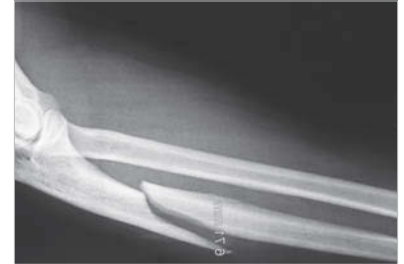
X-Rays

Indication: Nonunion of Midshaft Displaced Left Ulnar Fracture

Product: Acumed® 8-hole Locking Midshaft Ulna Plate

He underwent revision open reduction internal fixation. In this procedure, the nonunion was excavated and packed with bone graft. An Acumed 8-hole Locking Midshaft Ulna Plate was used this time with three screws proximal and three screws distal to the fracture.

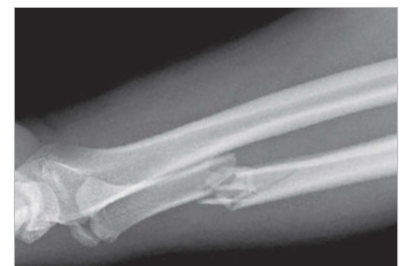
X-Rays

Indication: Comminuted Distal-Third Fracture of Right Ulna

Product: Acumed® 6-hole Locking Midshaft Ulna Plate

Several days after the injury, we completed open reduction internal fixation using an Acumed® 6-hole Locking Midshaft Ulna Plate. This plate was especially useful for this fracture because of the thinner, tapered ends. Towards the distal end of the ulna, the bone becomes very subcutaneous and easily palpable. A thicker 3.5mm DCP plate is frequently irritable and uncomfortable when near the distal end of the ulna.

Because the fracture was so comminuted, we were concerned about correct length and anatomic alignment. To this end, we were able to align the fracture and provisionally affix the plate to the bone with plate tacks. Once under fluoroscopy, we confirmed the length and alignment to be anatomic. We bridged the fracture due to the extensive comminution right at the fracture site, and additional bone graft was used. The patient's postoperative visits have been uneventful and he continues to heal without pain, displacement, or palpable hardware.

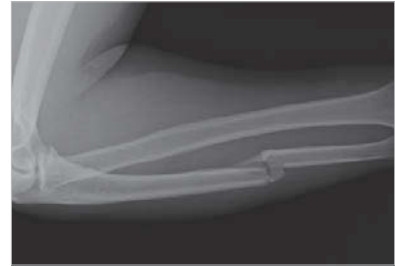
X-Rays

Indication: Diaphyseal Fracture of the Right Ulna

Product: Acumed® 8-hole Locking Midshaft Ulna Plate

The patient ultimately underwent an open reduction and internal fixation; an interfragmentary lag screw was used for the butterfly fragment and an Acumed 8-hole Locking Midshaft Ulna Plate was applied for compression. The patient healed with no postoperative complications.

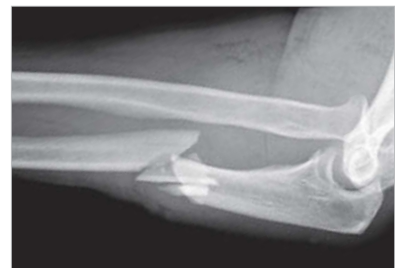
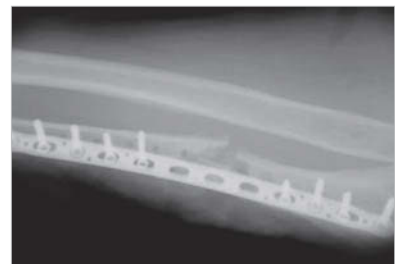
X-Rays

Indication: Grade 2 Open Fracture - Right Ulna

Product: Acumed® 12-hole Locking Midshaft Ulna Plate

Open reduction internal fixation with an Acumed® 12-hole Locking Midshaft Ulna Plate was performed to heal the fracture. Bone graft was used and the fracture went on to heal without incident. The patient had also sustained an ipsilateral hand injury which was treated operatively. The patient was followed closely and was fairly compliant with typical postoperative care. The initial nonunion was thought to be due to the high energy of the initial injury. Nevertheless, the second ulnar surgery that was done using the Acumed Locking Ulna Plate resulted in anatomic union.
